| | <b>INSPECTION REPORT</b> | Client: | XXX | <b>Conclusion</b><br><br><b>FAILED</b> |
| | | Inspection No.: | H014894 | |

| I. GENERAL INFORMATION | |
|---|---|
| Service Performed: | Pre-Shipment Inspection |
| Product Name: | Cap |

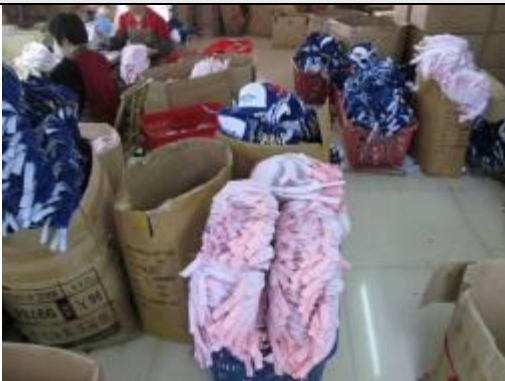
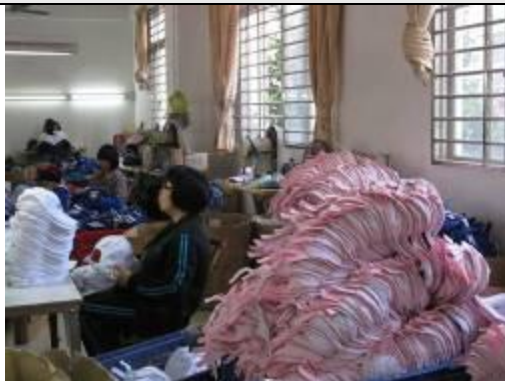
| III. REMARKS | |
|---|---|
| 1. | The quantity check was <b>failed</b> because production was not finished as required. Only 15.7% was packed into cartons, 48.6% were under packing, the rest 35.7% was under production. The inspected samples were randomly selected from the packed. Please check Section A for the breakdown. |

| Remark 1: products were under production (cleaning and trimmed thread ends) | Remark 1: products were under production (cleaning and trimmed thread ends) |

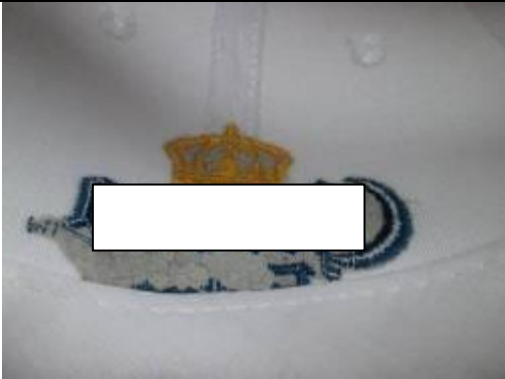
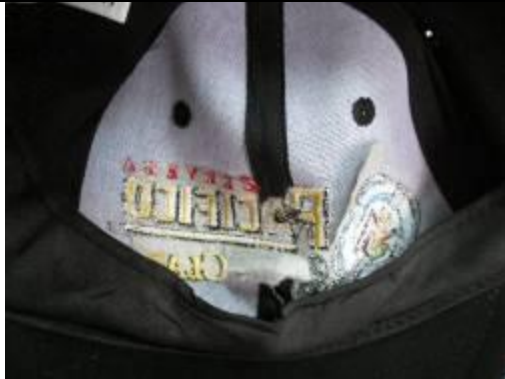
| III. REMARKS | |
|---|---|
| 2. | The embroidery paper on back side logo was not cleaned in all inspected samples. Please refer to below photos for details. |

| Remark 2: embroidery paper was not cleaned | Remark 2: embroidery paper was not cleaned |

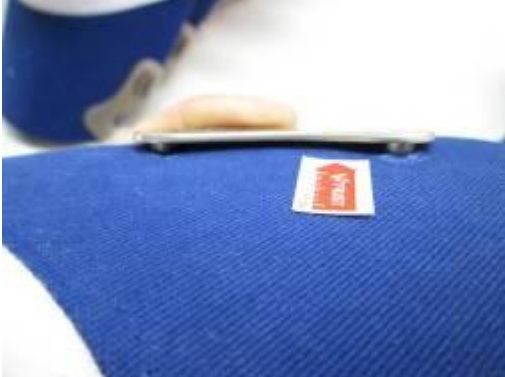
| III. REMARKS | |
|---|---|
| 3. | For item 021CE182 and 021CE192,<br>A. Obvious black mark at edge of the opener in 15.8% inspected samples. Please refer to below photos for reference.<br>B. Poor plating on the opener in 100% inspected samples. Please refer to below photos for reference.<br>C. The opener could be shaken by hand in 8% inspected samples. Please refer to below photos for reference. |

| Remark 3 (C): The openers were not tight enough and can be shaken by hand | Remark 4: The barcode in hangtag of Item 021CE186 was stuck on item 021CE184. |

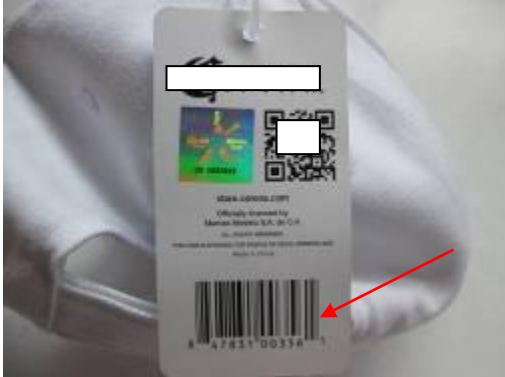
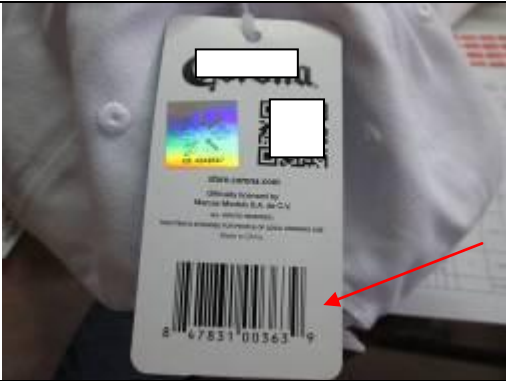
| III. REMARKS | |
|---|---|
| 4. | The barcode in hangtag of Item 021CE186 was stuck on item 021CE184. Please refer to below photos for reference. |

| Remark 4: The barcode in hangtag of Item 021CE186 was stuck on item 021CE184. | | Remark 5: the actual color of embroidery logo were closer to pantone 123C and 124C, while it was required as 108C and 125C | |

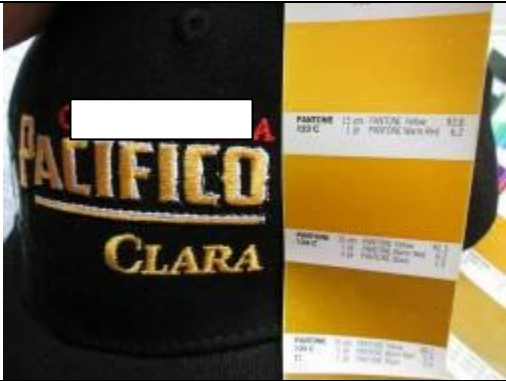
| III. REMARKS | |
|---|---|
| 5. | For item 021PC106, the actual color of embroidery logo were closer to pantone 123C and 124C, while it was required as 108C and 125C. Please refer to below photos for reference. |

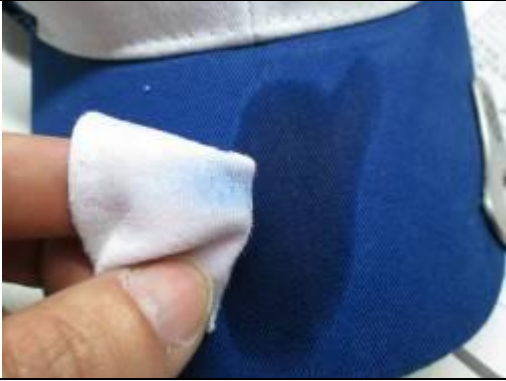
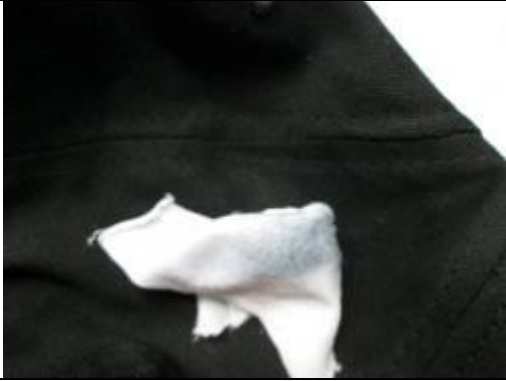
| III. REMARKS | |
|---|---|
| 6. | For item 021CE182 (Blue color), 021CE192 (Blue color) and 021PC106 (Black color), color stain on white cloth |

| after rub test. Please refer to below photos for details. | |

| Remark 6: color stain on white cloth after rub test. | | Remark 6: color stain on white cloth after rub test | |

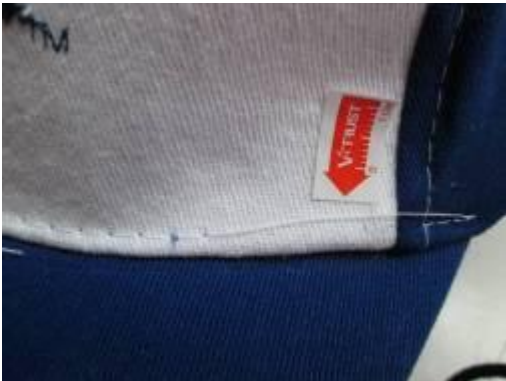
| 1. | skipped stitches edge | | | | 1 | |

| skipped stitches edge | Poor assembling on opener of the visor |

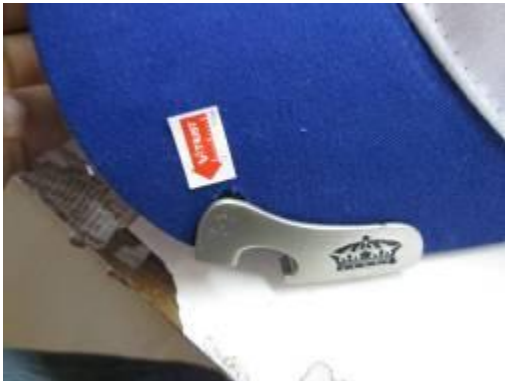
| 2. | Poor assembling on opener of the visor | | | | 1 | |

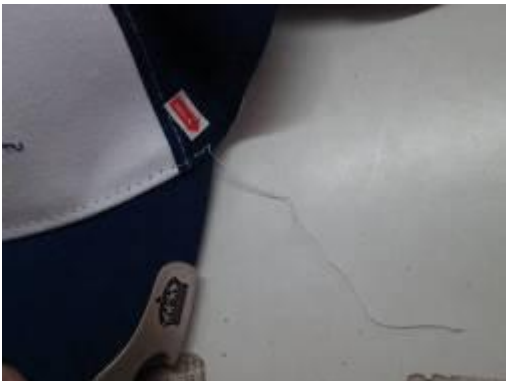
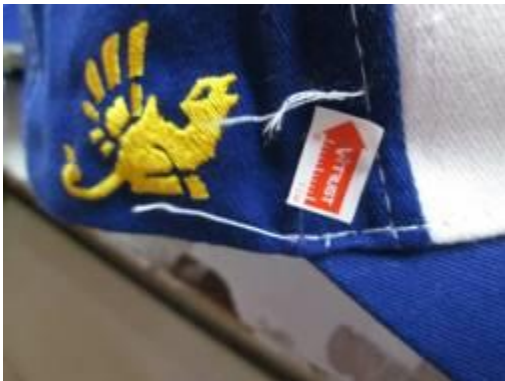
| Untrimmed threads on surface | Untrimmed threads on surface |

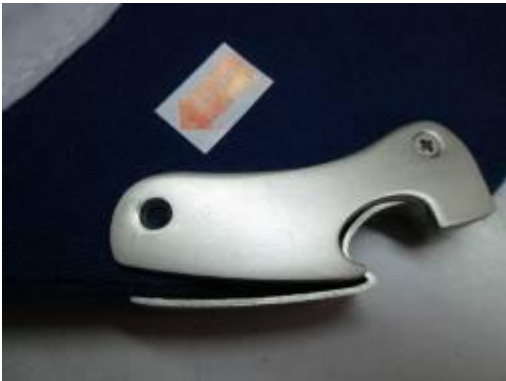
| 4. | Missed screw on opener | | | | 1 | |

| Missed screw on opener | | Nil |

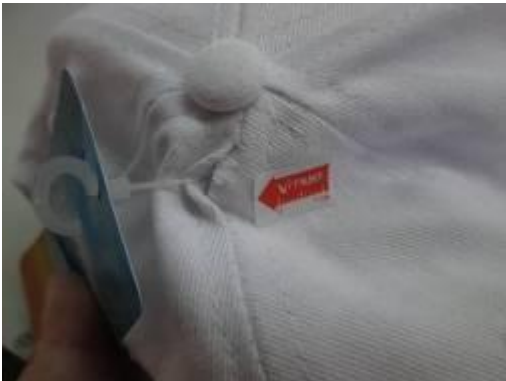
| 5. | Opened seam on top | | | | 1 | |

| Opened seam on top-Major | | Untrimmed threads on surface |

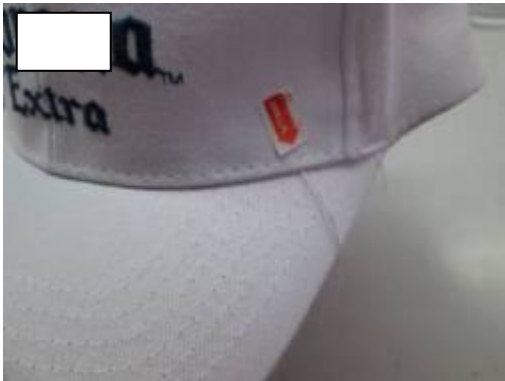
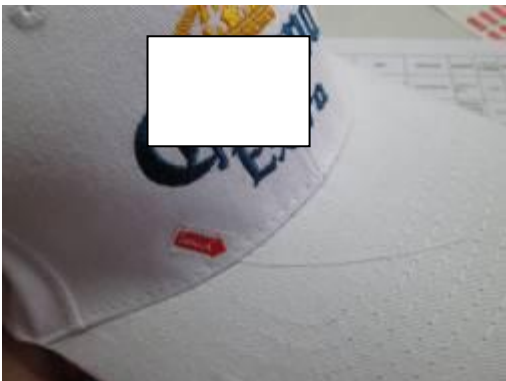
| Untrimmed threads on surface | | Nil |

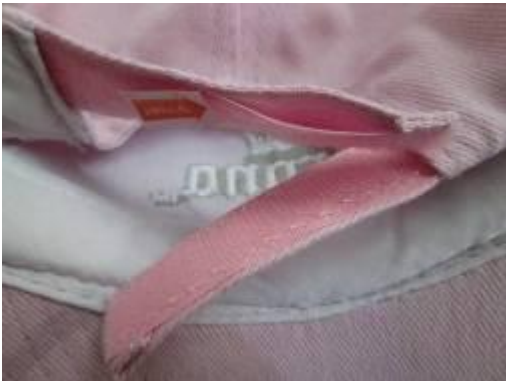
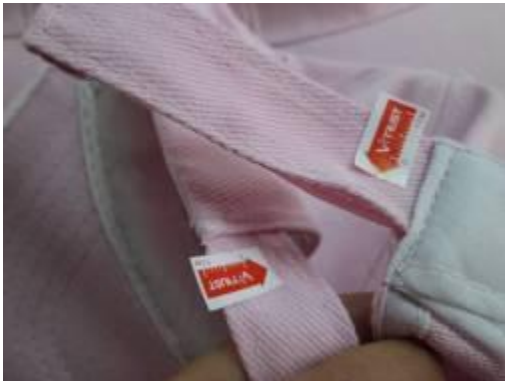
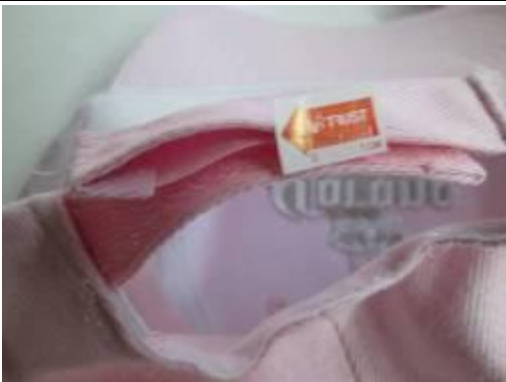
| 7. | Opened seam on Velcro | | | | 3 | |

| Opened seam on Velcro | Opened seam on Velcro |
| Opened seam on Velcro-Major | Dirty mark on surface |

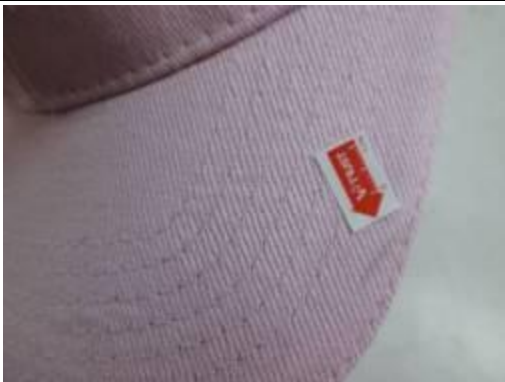
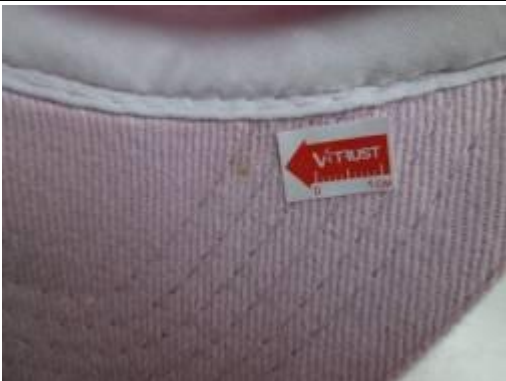
| Dirty mark on surface | Exposed raw fabric |

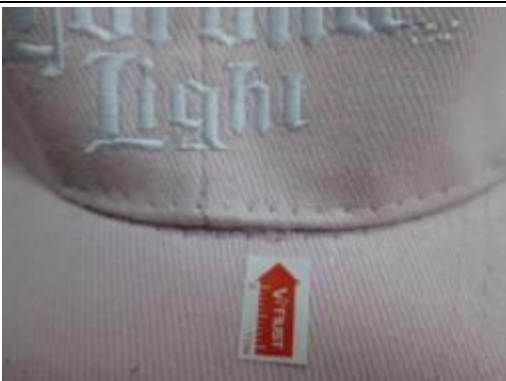
| Exposed under stitches | Untrimmed threads |

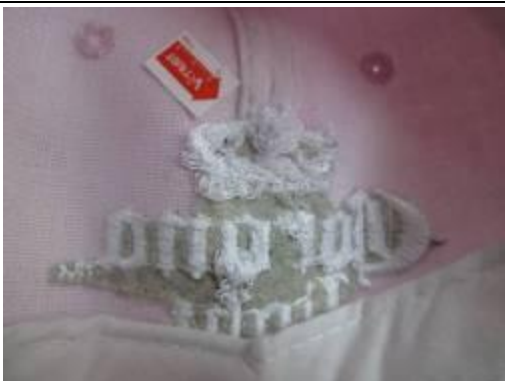
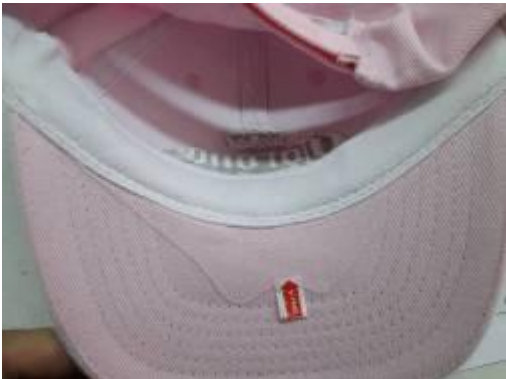
| Untrimmed threads | | Nil |

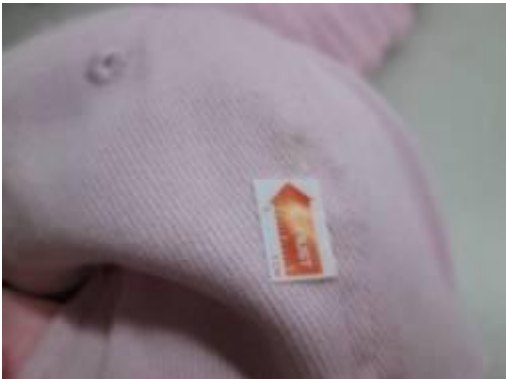
| Dirty mark on surface | | Nil |

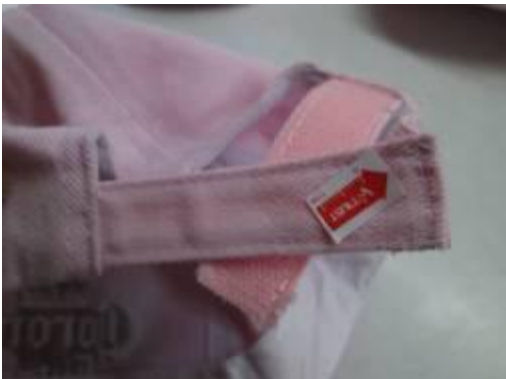
| Untrimmed threads | | Nil |
