| | <b>INSPECTION REPORT</b> | Client: | XXX | <b>Conclusion</b><br><br><b>FAILED</b> |
| | | Inspection No.: | H014894 | |

| I. GENERAL INFORMATION | |
|---|---|
| Service Performed: | Pre-Shipment Inspection |
| Product Name: | Cap |

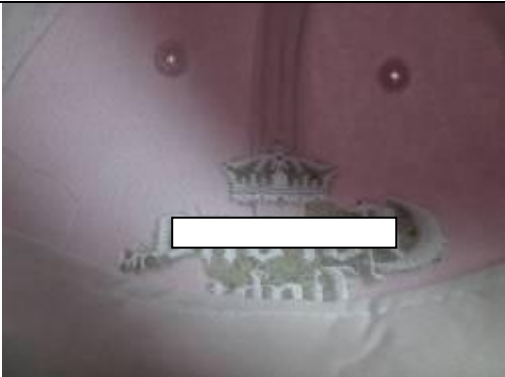
| Remark 2: embroidery paper was not cleaned | Remark 3 (A): Obvious black mark at edge of the opener |

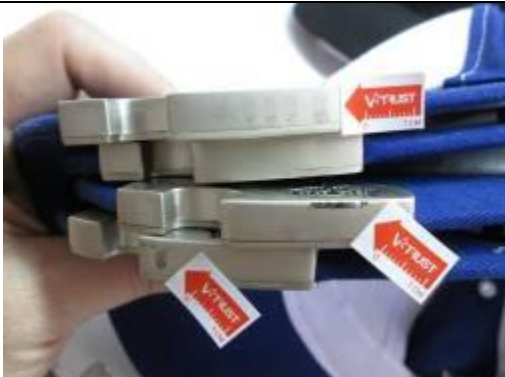
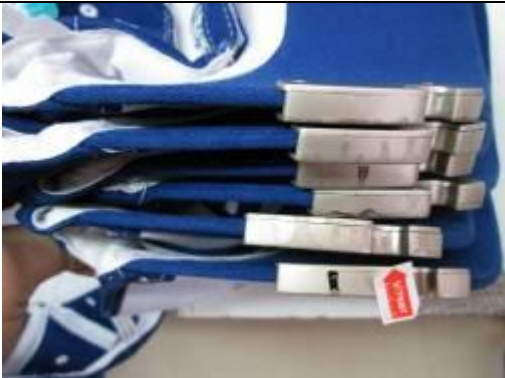
| Remark 3 (A): Obvious black mark at edge of the opener | Remark 3 (B): Poor plating on the opener |

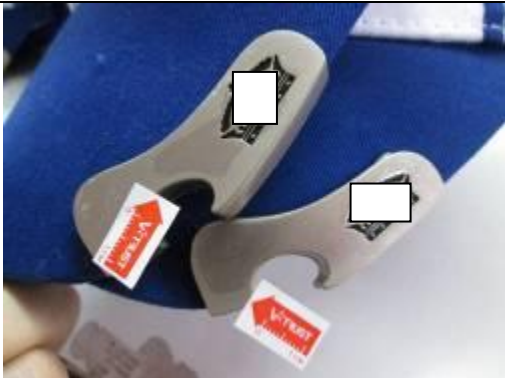
| Remark 3 (B): Poor plating on the opener | Remark 3 (C): The openers were not tight enough and can be shaken by hand |

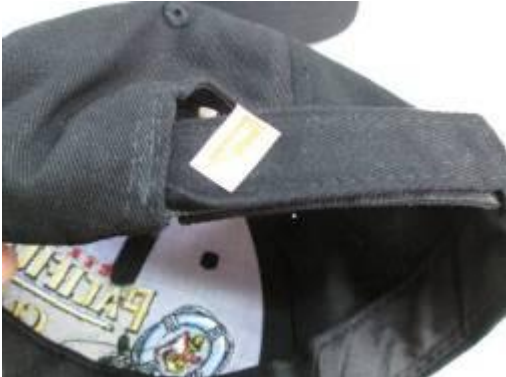
| Curling selvedge on Velcro -Major | Exposed under stitches |

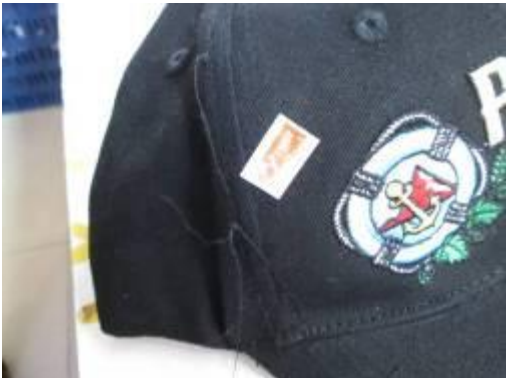
| Untrimmed threads | Nil |

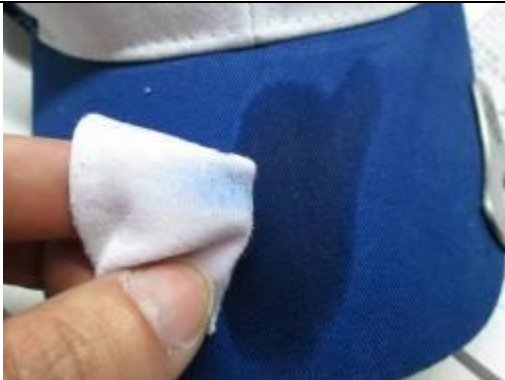
| Remark 6: color stain on white cloth after rub test. | | Remark 6: color stain on white cloth after rub test | |

| Remark: | <ul style="list-style-type: none"> <li>- For item 021PC106, the actual color of embroidery logo were closer to pantone 123C and 124C, while it was required as 108C and 125C.</li> <li>- For item 021CE182 (Blue color), 021CE192 (Blue color) and 021PC106 (Black color), color stain on white cloth after rub test.</li> </ul> |

| Rub check for blue color | Rub check result for blue color |

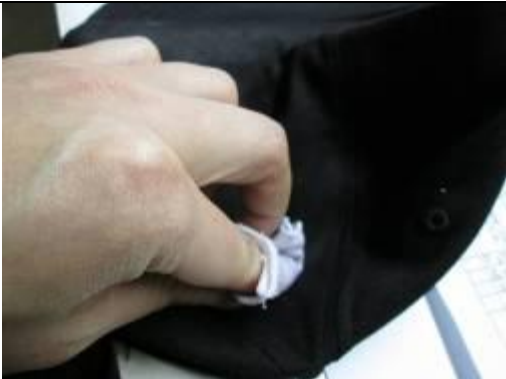
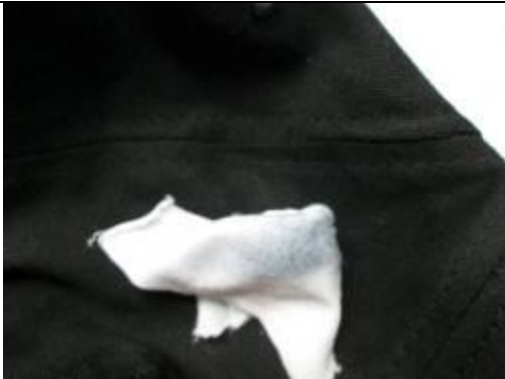
| Rub check result for black color | Rub check result for black color |

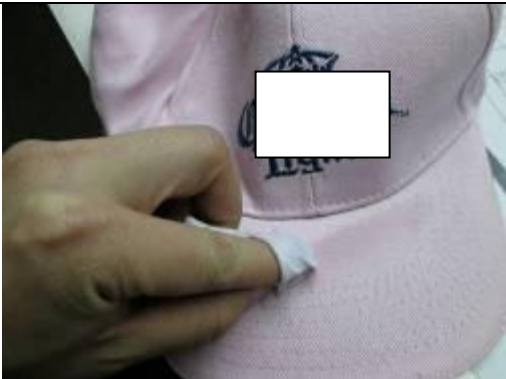
| Rub check result for pink color | Tape check for acc. |

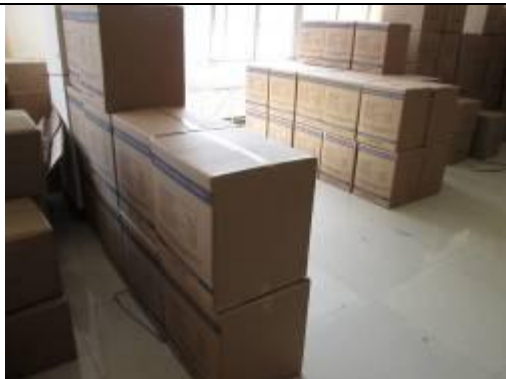
| Quantity | | | | | Unit: PCS | | | | |
|---|---|---|---|---|---|---|---|---|---|
| Remark: | - The quantity check was failed because production was not finished as required. Only 15.7% was packed into cartons, 48.6% were under packing, the rest 35.7% was under production. | | | | | | | | |

| Part of Mass products stocked in factory | | Nil | |
